NHTSA

Evaluation of THOR-05F in a Full Vehicle Crash Series

Erin Hutter¹, Allison Loudon¹, Kevin Moorhouse¹, Jason Stammen¹

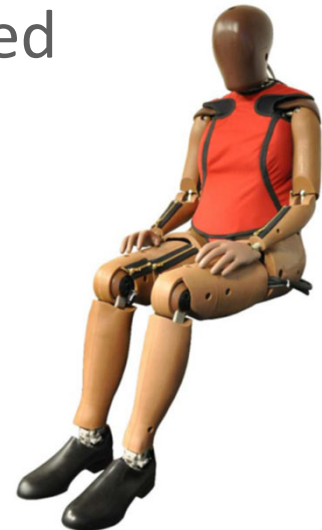
- NHTSA developed the THOR-05F ATD to better evaluate injury risk of small female adult occupants
 - Alternative to Hybrid-III in frontal crash tests
 - Improved biofidelity and measurement capability
 - More thoroughly evaluate & improve advanced restraint systems

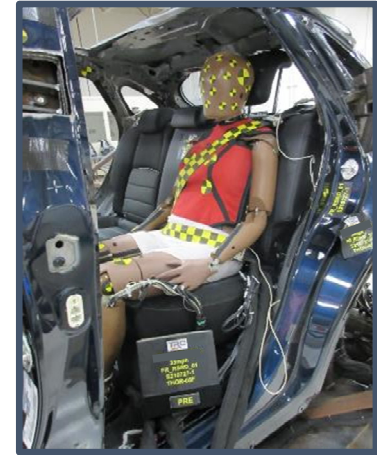
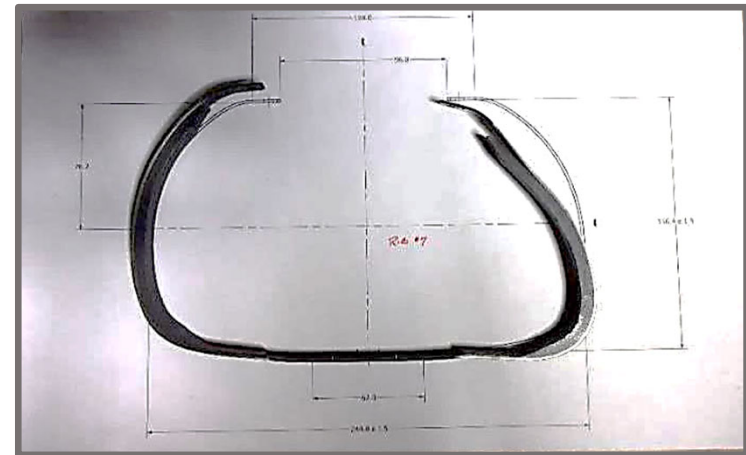
Durability Background

- Sled test series in 2019-2020
 - Rear seat occupant
 - Pulse: 35mph ΔV , 40g (similar to NCAP)
 - No load limiter or pretensioner
 - Key results:
 - Severe rib deformation
 - IR-TRACC failures

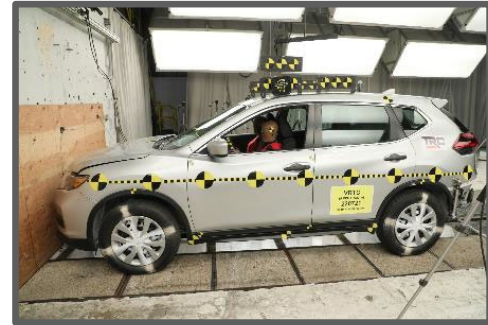
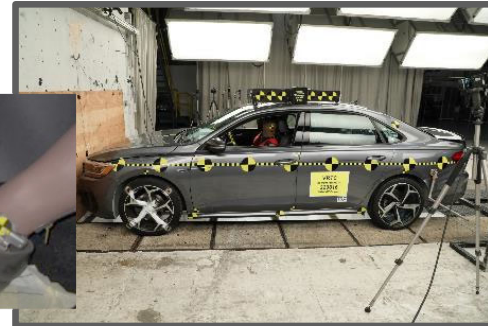
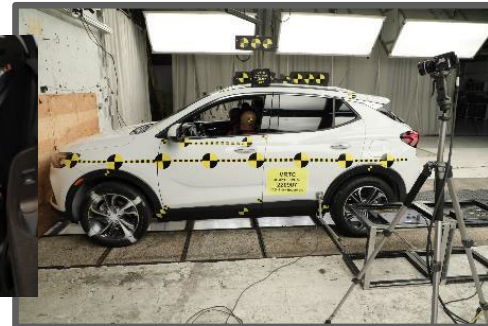
Vehicle Selection

- 2019 Nissan Rogue
 - Elevated neck & thorax loading on H3-5 in previous tests
 - FE model refinement (vehicle and THOR-05F)
- 2020 Volkswagen Passat
 - Elevated thorax & lower leg loading on H3-5 in previous tests
 - Hinged accelerator pedal
- 2020 Buick Encore
 - Elevated head & thorax loading on H3-5 in previous tests
 - Knee air bags

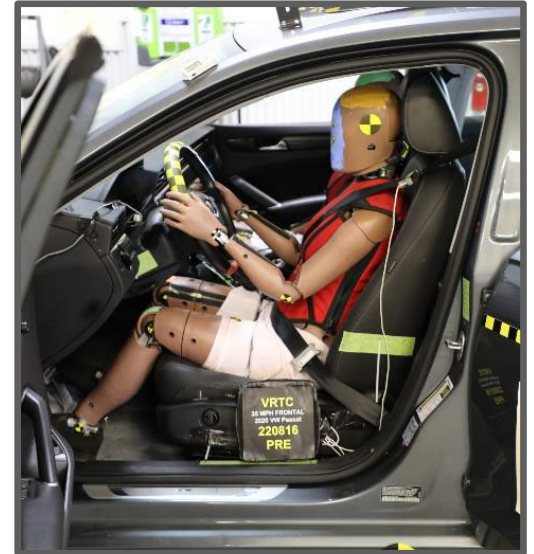
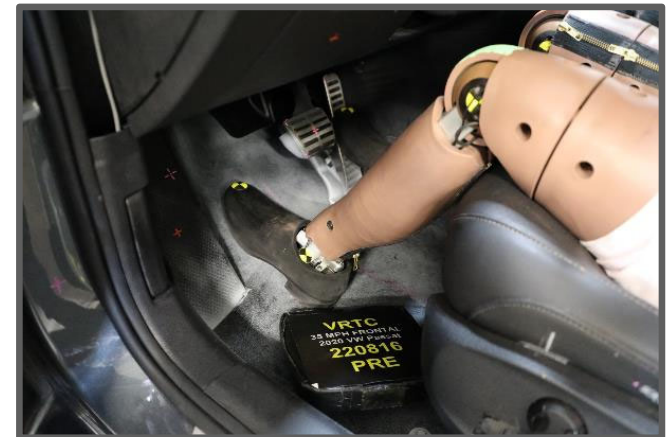
ATD Details

- THOR-05F
 - Driver & front passenger seats
 - Each instrumented with 113 channels
 - Fully qualified (preliminary corridors) prior to crashes, mid-series, and post-series
 - Damage inspection performed after each crash
 - Part repair/replacement and requalification tests were performed as needed
- Seating procedure - preliminary
 - Lumbar spine adjustment set to “erect” for front seat
 - Adjust the ATD to obtain pelvis at $20^\circ \pm 2.5^\circ$
 - Seat back adjusted to position head at $0^\circ \pm 1.0^\circ$
 - Move seat forward until contact with dash or full forward
 - Knees and feet equally spaced
 - Driver right foot on accelerator

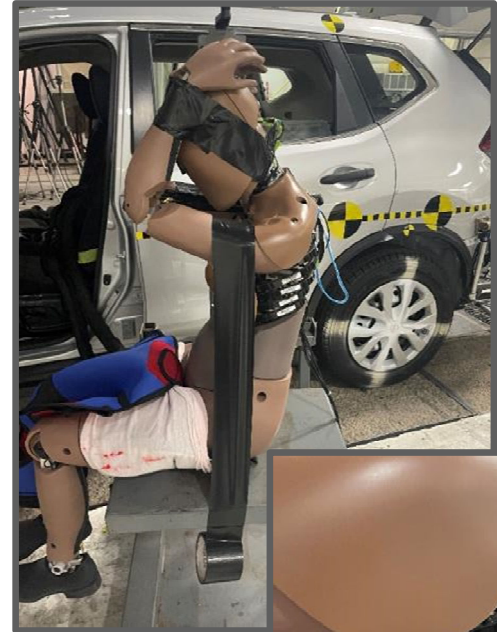
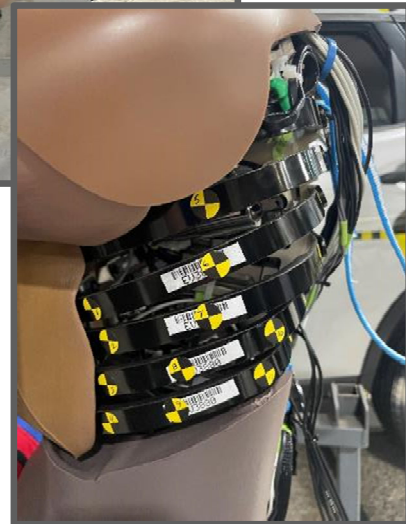
Rib Evaluation Method

- Needed a method to evaluate rib performance between crashes.
 - Avoid full tear-down inspection!
- Evaluation procedure:
 - Each ATD was seated on a chair & tilt sensors were recorded.
 - XYZ coordinates of 60 points were measured on ribs 1-7 pre & post-crash with the ATD in the same position.
 - Distances between the points were calculated (n=77).
 - Changes between pre-test and post-test distances were monitored.
 - Large change → inspect further for rib deformation

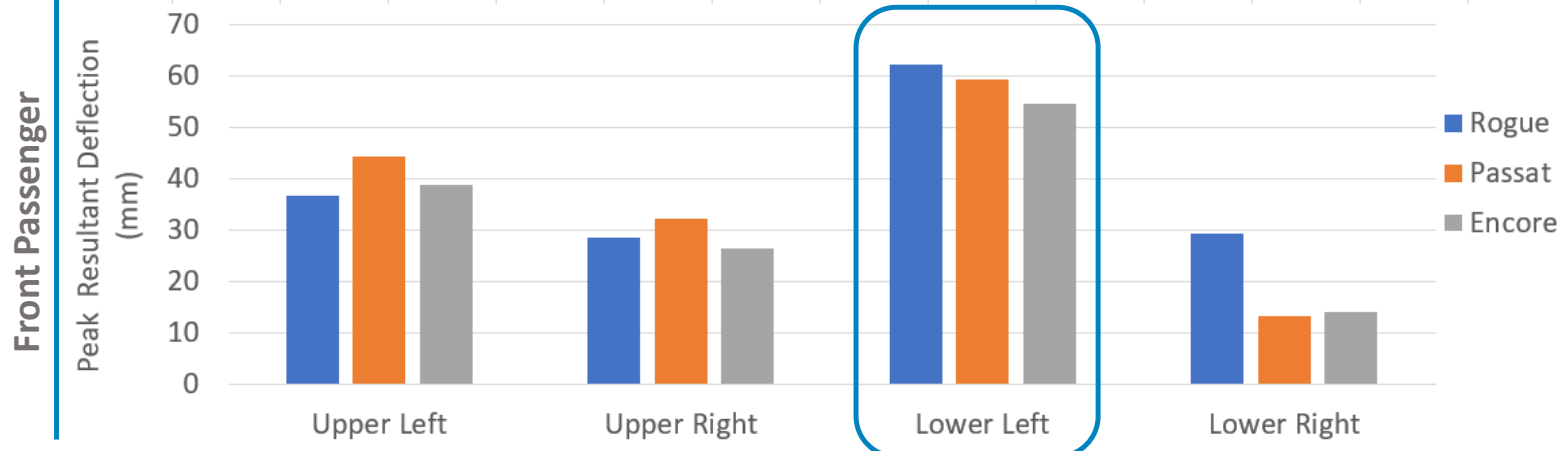
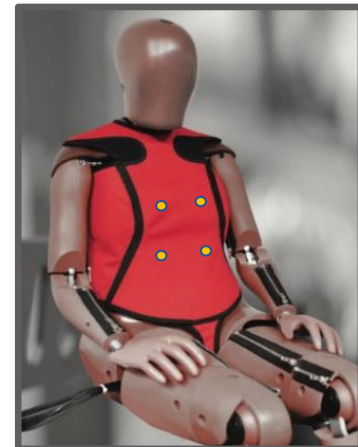
Belted 35mph Crashes: Thorax Data

- 4 IR-TRACCs measured chest compression

- Minor deformation to ribs 6 & 7 in a single belted test (35mph).
- IR-TRACC deflection:
 - 35mph Belted – Max at lower IR-TRACC closest to the seat belt buckle.
 - Range: 55-66mm depending on occupant position & vehicle.
 - 25mph Unbelted – Frequently greater than 35mph belted deflection.
 - Location of max deflection on the ATD varied.
 - Driver max deflection > passenger, likely due to steering column.
 - Range: 36-70mm depending on occupant position & vehicle.
- While high IR-TRACC deflections are a red flag for rib deformation, other variables (load distribution & rate) likely contribute.

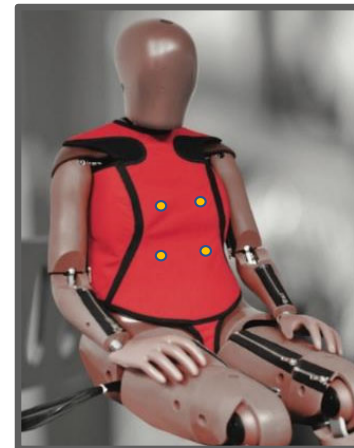
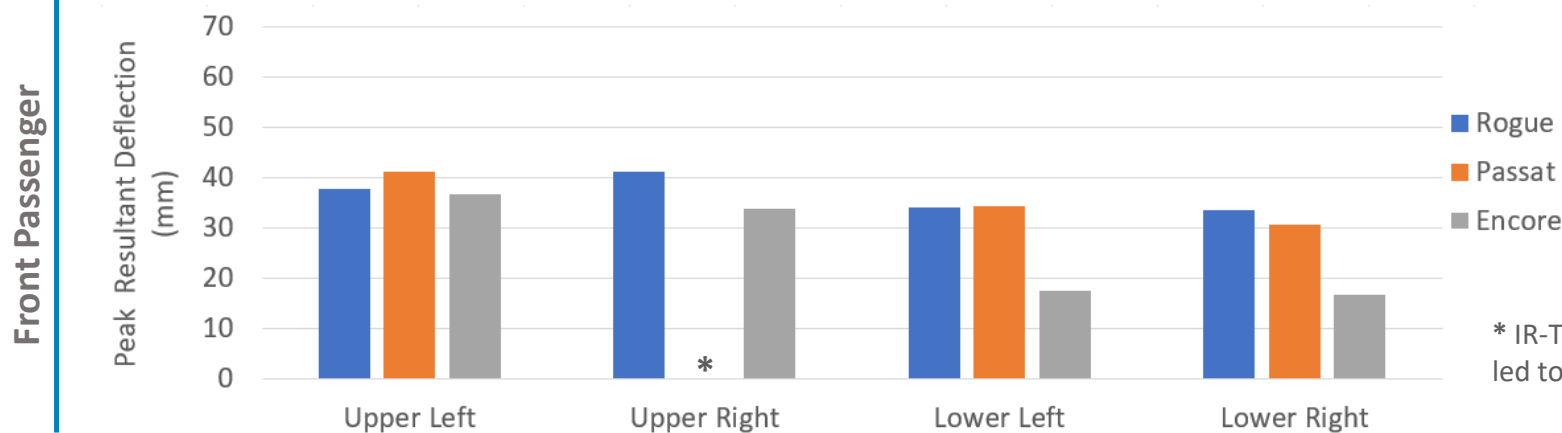
Unbelted 25mph Crashes: Thorax Data

- 4 IR-TRACCs measured chest compression

* IR-TRACC had a manufacturing defect that led to data anomalies.

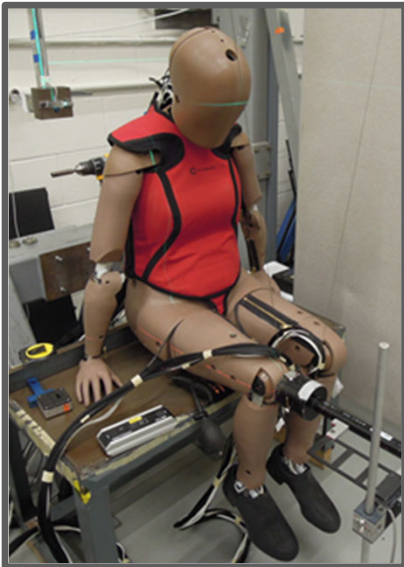
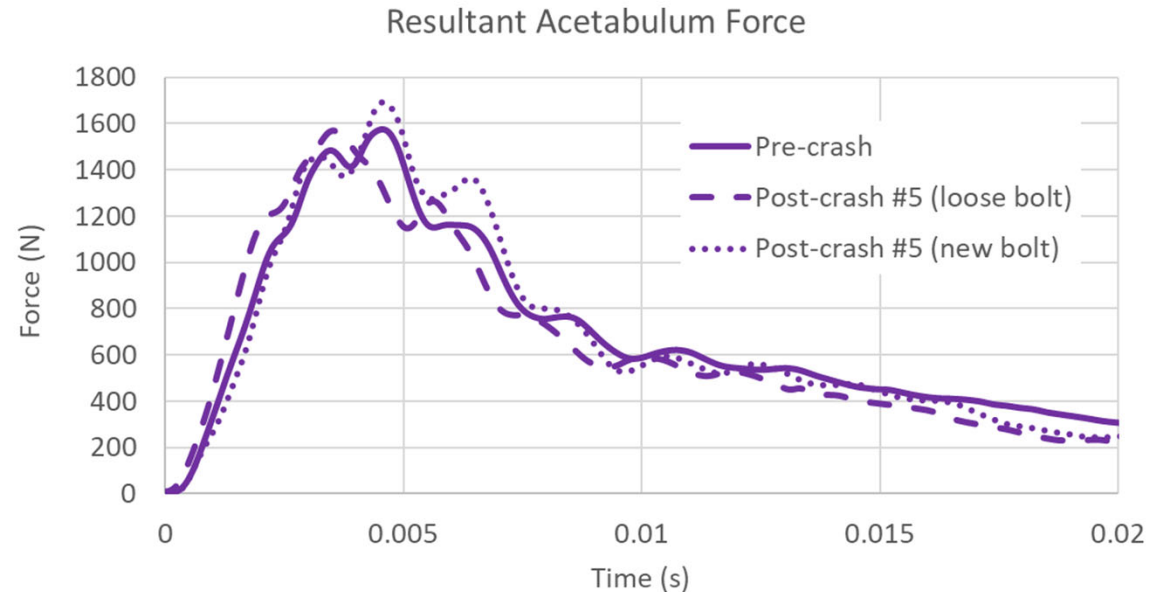
Leg Results

- No part or instrumentation failures in the THOR-05F legs.
- After 5 crashes, the bolt between the acetabulum load cell and femur loosened slightly.
- No effect on left upper leg qualification performance!
 - Knee impact on a seated ATD with a 7.26 kg probe at 3.3 m/s.
- Replaced the bolt & requalified.

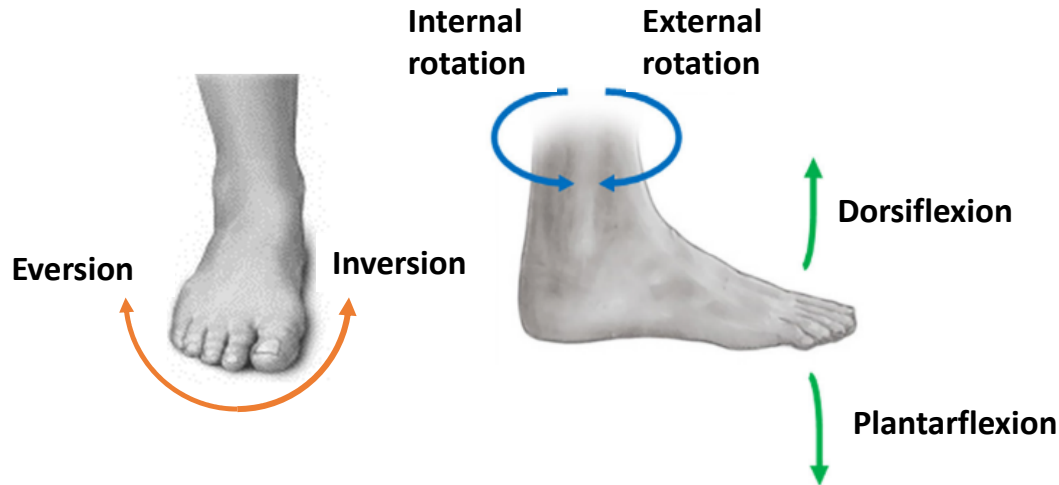
Lower Leg Results Summary

- Ankle displacement: 6 tests, 2 THOR-05Fs each with 2 ankles that have 3DOF.
 - Highly dynamic & variable response.
 - Crash series exercised the ankle joint through a large range of motion.
 - In general:
 - Ranges of rotation about each axis were similar for the belted & unbelted tests.
 - More rotation about X & Y axes than the Z axis.
 - Data that can't be collected on a Hybrid III-5th.

Measurement		Belted (35mph)		Unbelted (25mph)	
		Peak Rotation (°)	Range (°)	Peak Rotation (°)	Range (°)
X-Axis	Inversion	48.6	85.1	49.8	89.1
	Eversion	36.5		39.3	
Y-Axis	Plantarflex	28.2	64.6	35.2	69.1
	Dorsiflex	36.4		33.9	
Z-Axis	Internal	10.2	35.4	10.7	34.3
	External	25.2		23.6

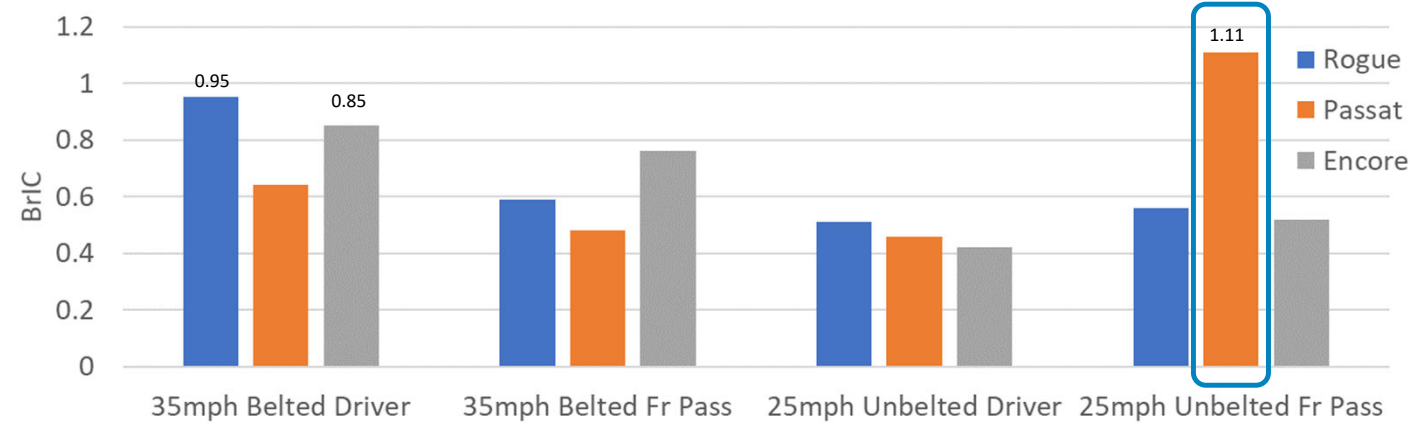
- Max BrIC (1.1) occurred during an unbelted test despite the lower speed.
- Nissan Rogue belted driver resulted in BrIC of 0.95

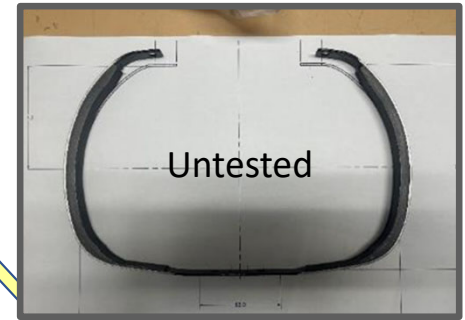
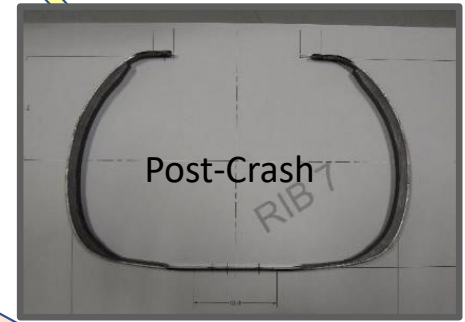
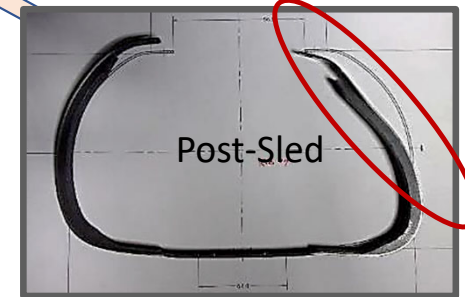
Discussion: Thorax Durability

Test	Vehicle	ATD seat	ATD posture	Max Chest Deflection		Rib Deformation	
					mm	IR TRACC location		
Front Seat	Full Vehicle Crashes	Belted	Rogue	DR	Erect	66.0	Lower Right	< 10mm
				Pass	Erect	62.3	Lower Left	No
			Passat	DR	Erect	59.4	Lower Right	No
				Pass	Erect	59.3	Lower Left	No
			Encore	DR	Erect	54.5	Lower Right	No
				Pass	Erect	54.5	Lower Left	No
		Unbelted	Passat	DR	Erect	65.0	Lower Right	No
				Pass	Erect	41.2	Upper Left	No
			Rogue	DR	Erect	70.0	Lower Left	No
				Pass	Erect	41.2	Upper Right	No
			Encore	DR	Erect	36.1	Upper Right	No
				Pass	Erect	36.7	Upper Left	No
Rear Seat	Sled Tests	Belted	Mazda Buck	Rear Left	Erect	75.3	Lower right	Severe
			Mazda Buck	Rear Left	Slouch	61.6	Lower right

- Rear seat sled test is the most severe loading condition measured thus far.
- NHTSA currently has a contract to redesign the THOR-05F thorax to address durability concerns.
